# New Fresh Wharf: 1, The Roman Waterfront

JOHN SCHOFIELD  
LOUISE MILLER

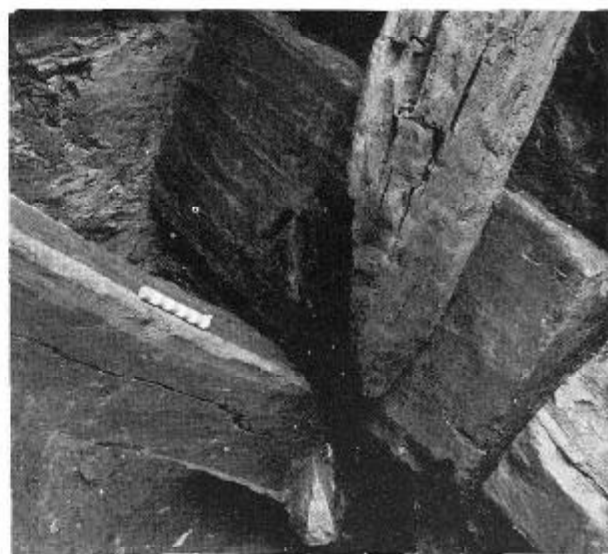
Fig. 6. Details of carpenter's mark on back of sill-beam.

two ends are from the same beam, in which case it was 7.95m long, with a section at its thickest of 37 x 74 cm (1½ x 2½ Roman feet). The sill-beams butted at their ends, again allowing for slight changes in direction. At the west end of one beam (fig. 3: 378) a carpenter's mark on the back edge of the beam was found (fig. 6); a figure IV in slightly sloping script, V-cut as in stone inscriptions, of uncertain purpose but perhaps related to the unusual jointing of a diagonal brace to a groundpile via a nailed scarf at this point.

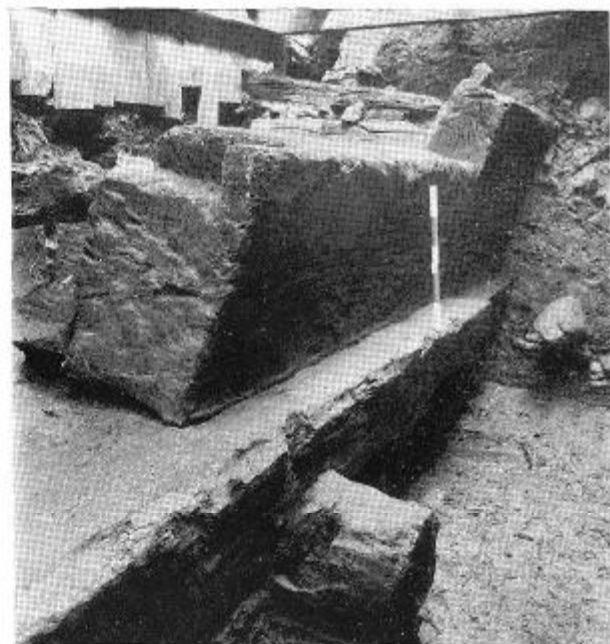
Fig 7. Roman waterfront looking east (compare fig 3).

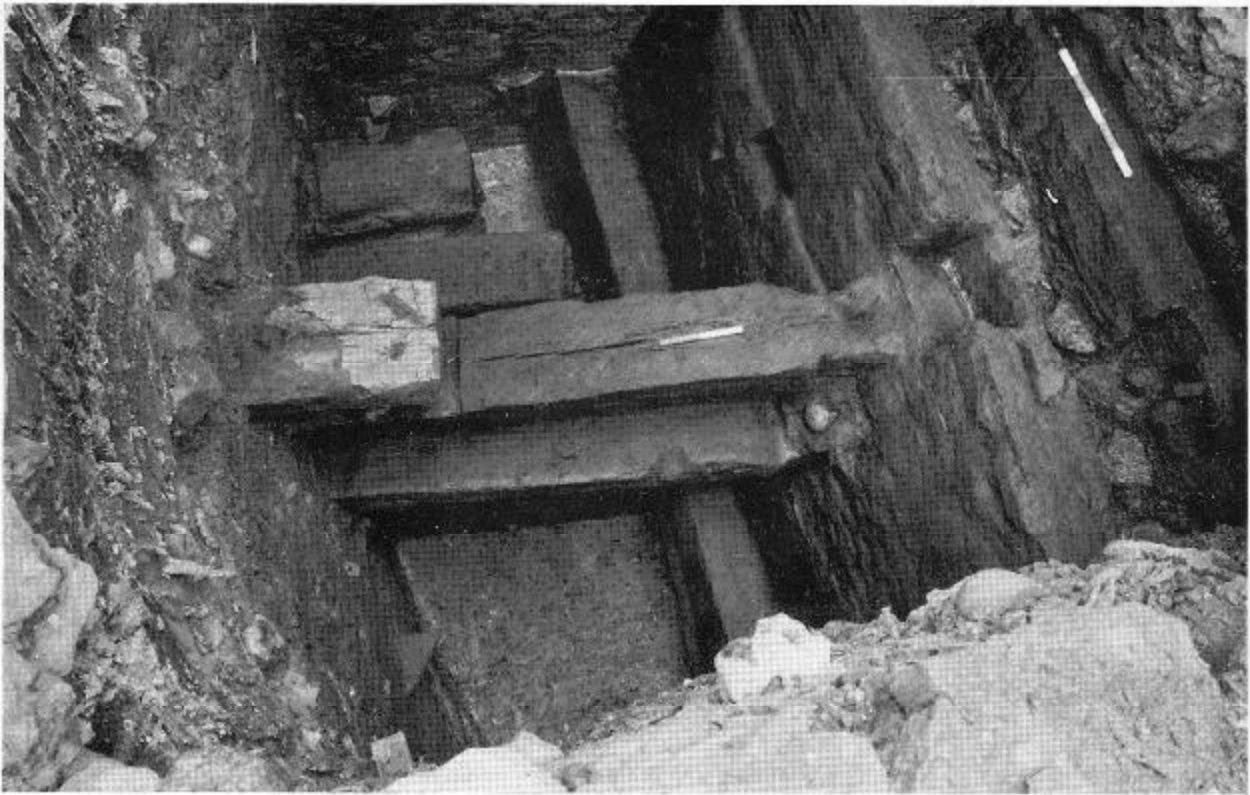
Fig 8. Interior of waterfront at east end of Area III, showing nailed tiebacks.

with the *first tiebacks* (fig 8), which jointed in turn with the structural piles, halved and nailed. Above the *second row* came the *third row of quayfront beams* (fig. 5: 9), of section 39 x 23 cm (1½ x ¾ Roman foot) and jointed to them the *second tiebacks* (fig. 5: 10). From these diagonal braces went down to groundpiles beneath some of the sill-beams (fig 8). The *fourth layer of quayfront beams* (fig 5: 11) did not survive in position in either trench, but one example was found on the shore in front in each trench (fig 8). These were again smaller, 18 x 30 cm (¾ x 1 Roman foot). Nails in the sides of the structural piles indicate a fifth layer, later removed. Thus in Area II, on which fig 5 is based, tiers of tiebacks made a rough box structure.
