# New Fresh Wharf: 2, The Saxon and Early Medieval Waterfronts

LOUISE MILLER

THE EXCAVATION of the Roman Waterfront was discussed in the first article on New Fresh Wharf in *the London Archaeologist*. Significant Saxon features were found in both Area II (New Fresh Wharf)<sup>2</sup> and Area III (St Magnus)<sup>3</sup> excavated in 1974 and 1975 (fig. 1) with early Medieval features above.

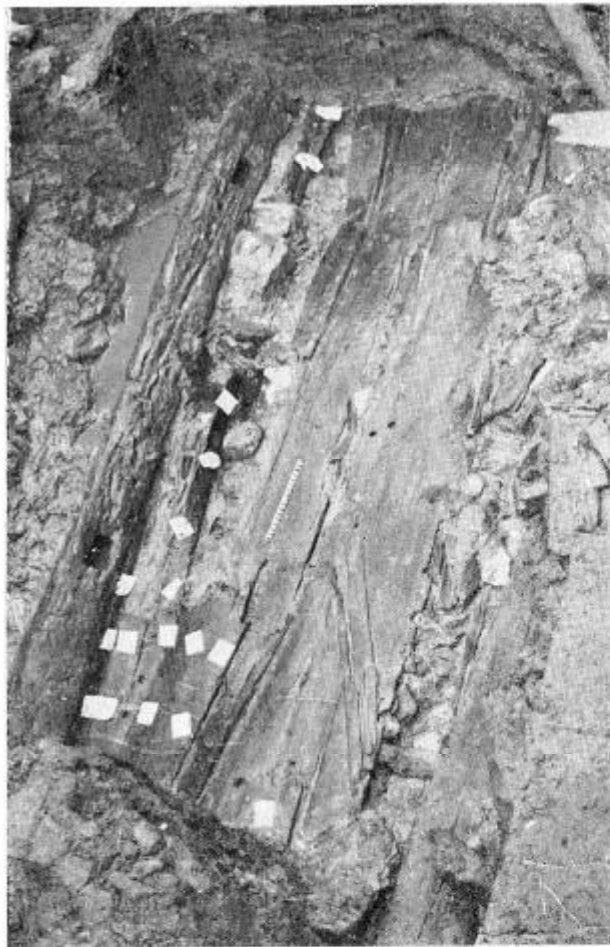
Fig. 2: Saxon boat.

going into the rubble underneath a re-used Roman beam, over 4.40m long, which revetted the upper part of the bank. A C14 date from the logs was  $760 \pm 100$ ; they supported layers of strakes from a clinker built boat and other planks which formed a flat surface (fig. 2). The whole structure lay about 7.25m south of the present Lower Thames Street and only the remains of two rows of posts, one just behind the collapsed Roman waterfront and the other row 3.60m to the north, suggests that there was any structure behind the bank on the landward side. On the river side the bank extended south for 2.60m without the limit being established in the trench.

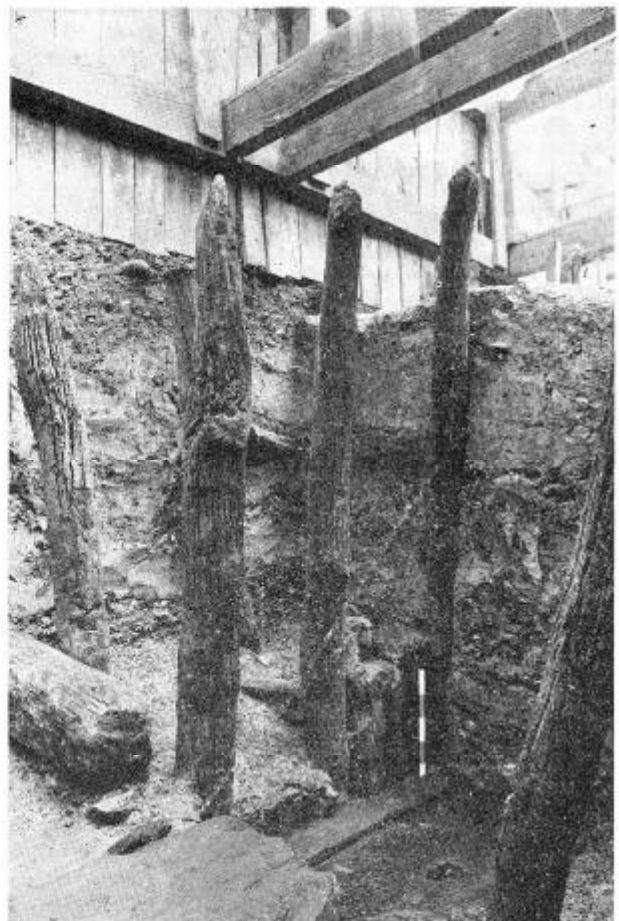
Fig. 3: Saxon timbers, area III.

In Area III the first phase of activity after the robbing of the Roman waterfront, dated to  $870 \pm 60$ , consisted of the erection of a large number of vertical posts: 47 were found in the excavation but they clearly extended both north and south (fig. 3;

was 1.20m high reaching a level of O.D. and was revetted internally by logs laid east-west about 2.00m long piled one above the other. The bank was also covered by similar logs which were piled between the vertical posts (fig. 4). A large boulder over 1.23 x 0.70m was incorporated, making a simple but solid bank. It was probably a continuation of the bank found in Area II, thus making a total of 19m of Saxon embankment. Small posts were found driven against or into the Roman waterfront just north of the rubble bank in Area III, being about 1.38m high and reaching 0.28m O.D. This line of posts turned northwards at the point where the second beam of the Roman waterfront had been robbed (fig. 3).

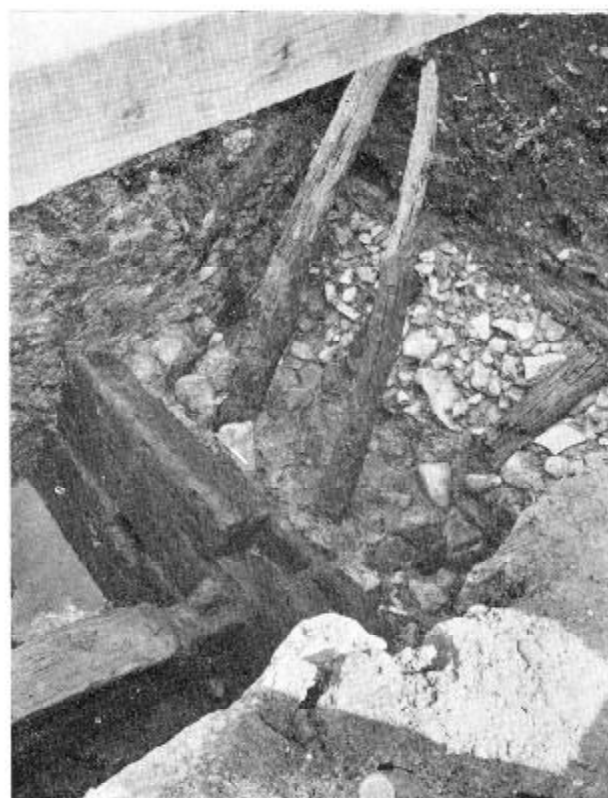
Fig. 5: Saxon timbers and rubble bank, Area III.

At the east end of Area III, possibly later than the above features, a rubble bank, of Roman tile and building material, Kentish rag, and small pebbles was built round the easternmost closely spaced rows of vertical posts (fig. 4: fig 5). It was 1.50m north south stacked against the three surviving beams of the Roman waterfront and extending 5.00m to the west where it was revetted by a tree trunk. It

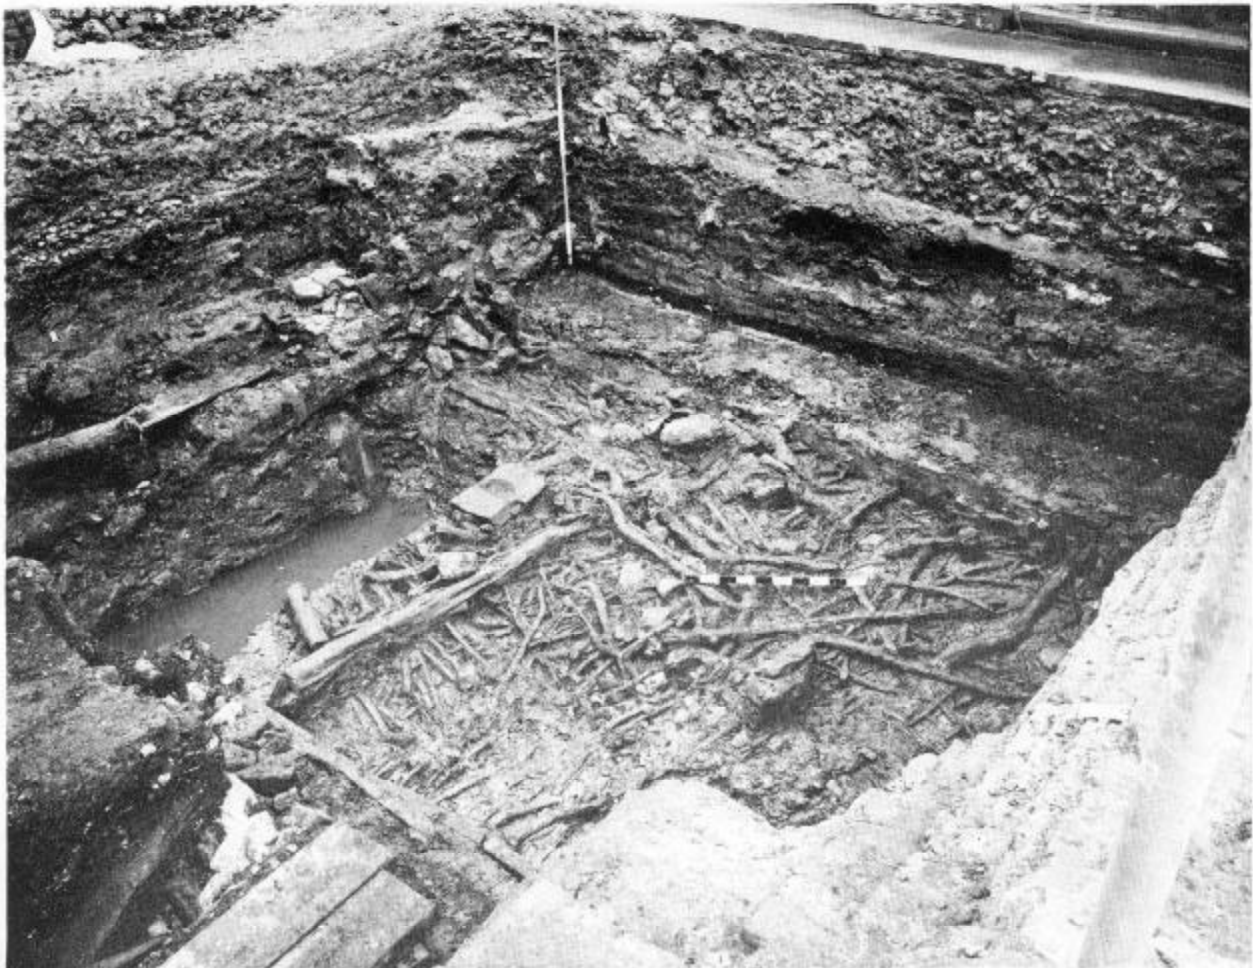
Fig. 7. Base of early medieval embankment, Area II.

The layers of dumping up to 1.00m high seem to have been held in place by an arrangement of logs, planks and posts into box-like formations (fig. 7) or by planks placed along the tip line of a layer and held in place by posts. These timbers were not jointed together and a rare instance of a morticed timber being used consisted of a wedge-sectioned plank with a mortice 0.12 x 0.18m cut through it but with two round sectioned stakes in the mortice hole. This is but one example of a number of re-used timbers with joints or pegholes cut in them, making rather poor specimens of Anglo-Saxon carpentry.

In Area II (fig. 7) there was a line of short stakes driven into a pile of rubble which ran east west across the trench 1.20m wide with a collection of re-used timbers, logs, branches and planks twined

around the stakes to form "hurdling" dividing the clay dumping from organic dumping to the south. The latter may not have been contemporary with the clay on present provisional pottery dating, and with the lower levels of the clay stretching south under the hurdling, apparently coming to an end at a pile of rubble and stakes at the southern limit of the trench, the clay dumping itself closely resembles the Anglo-Danish embankment at York, dated to the 10th to 11th century<sup>10</sup>.
