## Medieval Buildings at Trig Lane

GUSTAV MILNE  
CHRISSE MILNE

A DETAILED ANALYSIS of the medieval riverfront reclamation investigated on the Trig Lane site from 1974-6 (TQ 326 808) will be published later this year<sup>1</sup>. However, the buildings recorded during that excavation are not assessed in that particular report, and the purpose of this short paper is to summarise the evidence for these structures and to establish their context.

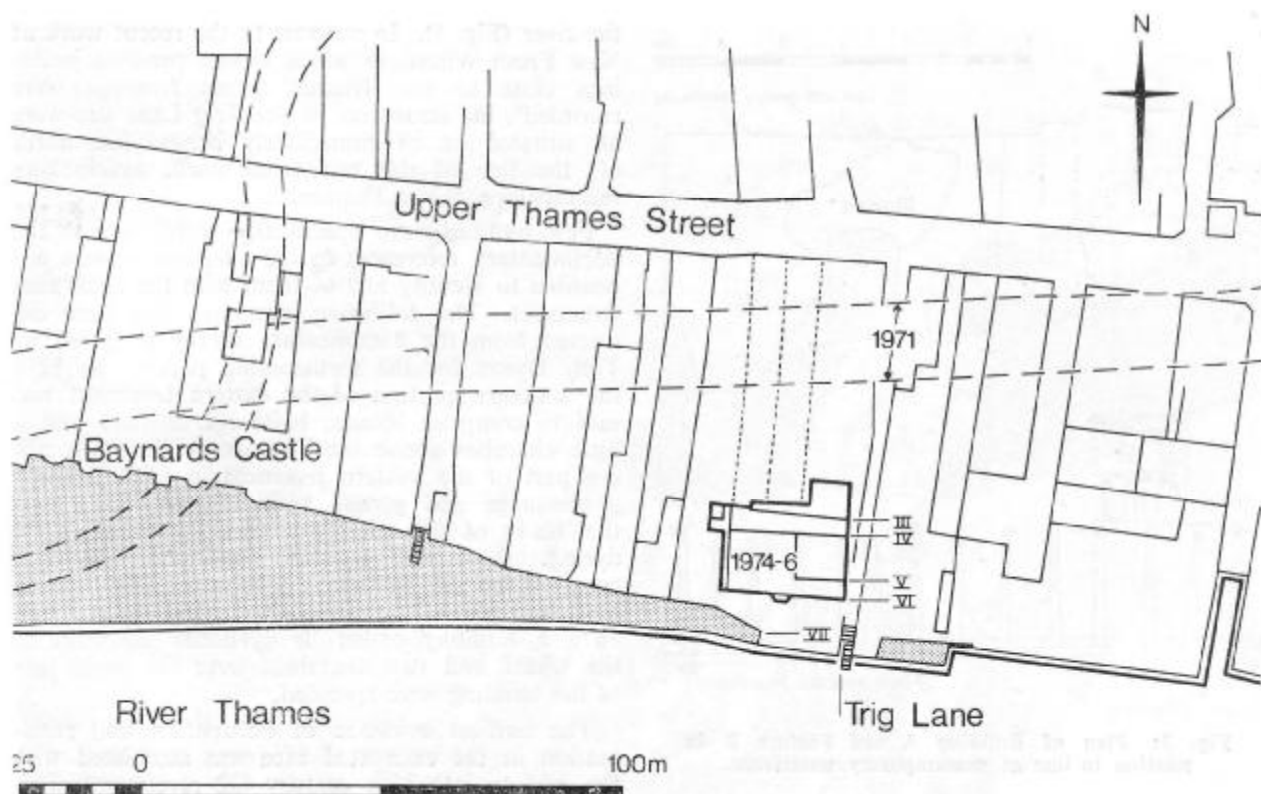
Fig. 1: Site of 1971 and 1974-6 excavations in relation to pre-Fire waterfront and former line of Thames Street. Dashed line shows present day street alignment, dotted line assumed medieval property boundaries. Chronology of waterfront reclamation: Period III — mid 13th century; Period IV — mid 14th century; Period V — late 14th century; Period VI — mid 15th century; Period VII — post 17th century (shown toned).

From 1974-6 the Museum of London's Department of Urban Archaeology excavated a 450m<sup>2</sup> site to the west of Trig Lane, just south of the line of Upper Thames Street (Fig. 1). The detailed examination of this area showed that it had been gradually reclaimed from the river, from the 13th to the 15th century. This process was effected by erecting a timber or stone revetment upon the foreshore to the south of the contemporary frontage, and infilling the intervening area with dumps of refuse sealed by a stone or gravel surface<sup>3</sup>.

the river (Fig. 1). In contrast to the recent work at New Fresh Wharf, in which eleven pre-Fire buildings close to the Thames Street frontage were recorded<sup>5</sup>, the structures on the Trig Lane site were all situated on or immediately behind (i.e. north of) the line of the waterfront itself, overlooking the medieval River Thames.

ran east-west across the site on the line marked Period III on Fig. 1. A worn gravel surface sealed the dumped deposits to the north of the G2 revetment over most of the excavated area, and was interpreted as an external surface. In the north west corner was an occupation deposit of dark grey silt c. 100mm (4in) thick, immediately to the south of which traces of a possible base plate were recorded. These features comprised the evidence for the earliest phase of Building A. They were all sealed by a substantial deposit of Purbeck marble chippings which formed a clearly defined external surface over the area exposed to the north of the G2 revetment. Three superimposed floors overlay the stone surface in the same position as the earlier internal floor, suggesting that Building A was rebuilt and continued in use for some time after the area had been resurfaced (Fig. 2). Three metres to the east of Building A was an irregularly shaped area of staining on the stone surface c. 3m

Evidence of a number of external surfaces associated with the Period IV alignment (Fig. 1) were recorded. Some were compacted loam, others gravels, some compacted sandy deposits with many roof tile fragments, and one was a distinctive light green crushed stone. A poorly defined mortar floor c. 5.8m (19 ft) north-south but less than 2m (6½ ft) wide was the only evidence recorded for possible occupation overlaying the G11 extension of c. 1380 (Period V, Fig. 1).

A number of possible internal surfaces were recorded in the western half of the area reclaimed behind the G15 river wall (Period VI, Fig. 1). In the eastern half of the site, a more substantial fragment of a building survived, which may also be contemporary with the phase of 15th to 16th century development, although this relationship cannot be proved. This was Building E, which may have been a narrow building running north-south against the western edge of Trig Lane (Fig. 7). It comprised a trench built ragstone wall enclosing a floor of orange-red hand made bricks and three sunken compartments. Two of these were sub circular oven-like bases c. 1m (3ft 3in) diameter, which may have had any of a number of functions from baking bread to heating dyers' vats.

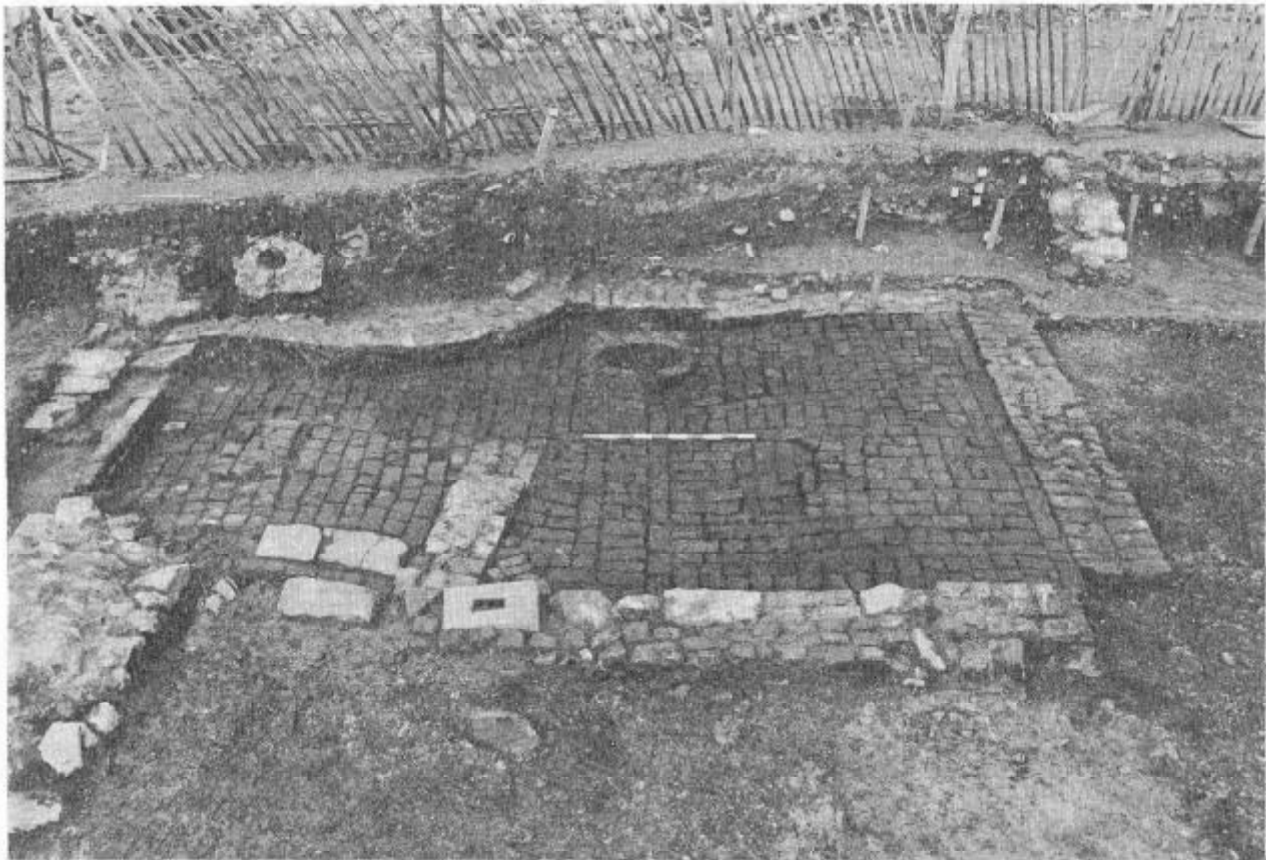
Fig. 8: Building F, situated in northwest corner of site, looking N.  
10 x 100mm scale Photo T. J. Hurst

Fragmentary remains of buildings, drains and other features associated with the 16th-17th century Period VI advance of the waterfront were found, of which the best preserved was Building F. Fig. 8 shows its asymmetrical plan and its hand made brick floor with a wooden barrel set into it.
