## Excavations at Watling Court Part 1: Roman

DOMINIC PERRING

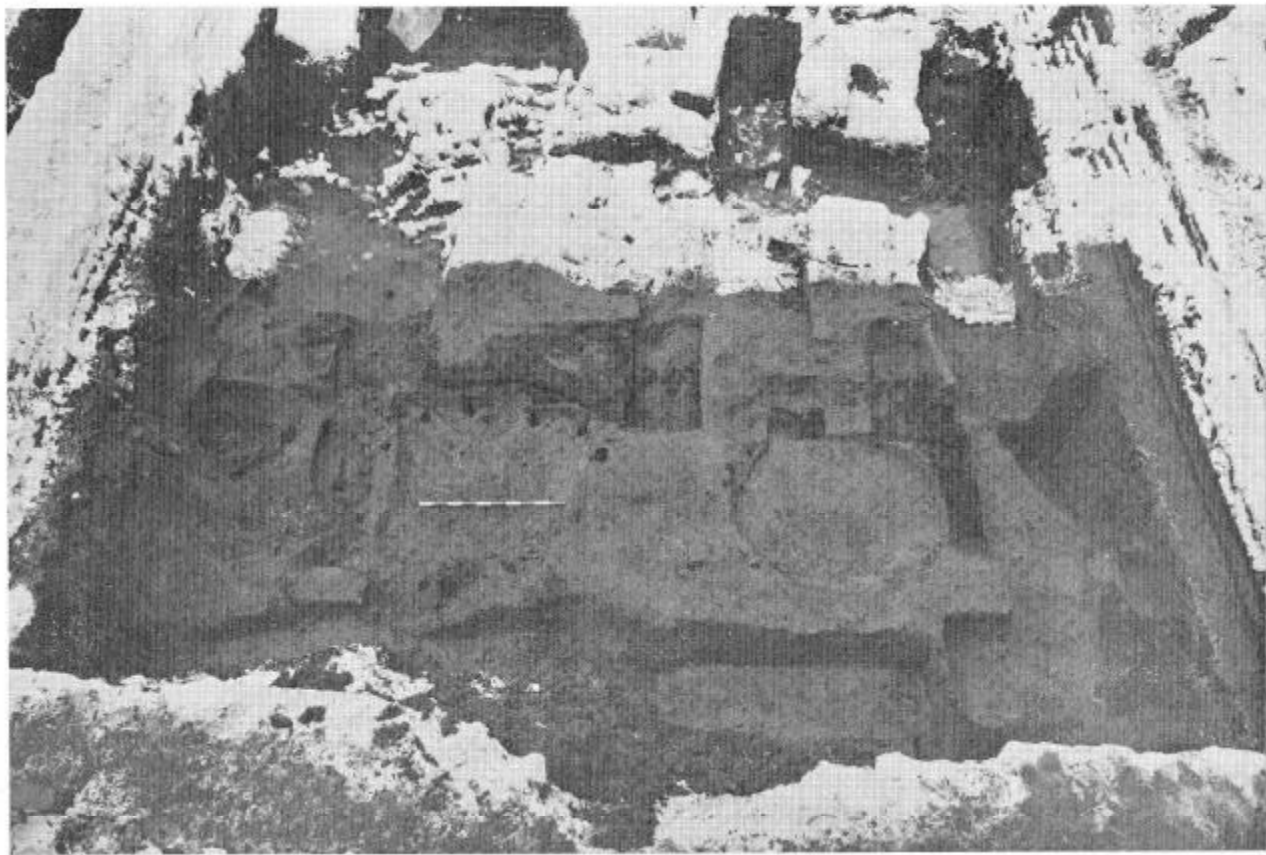
Fig. 1: Traces of the timber floor of Structure 2. The scale is in 0.10m (4in) units.  
(Photo: Trevor Hurst)

These rectangular buildings (Fig. 1) may have been timber framed, but the walls were so slightly founded that their positions could only be determined from the extent of the floor surfaces. The destruction debris included many fragments of air-dried or poorly fired bricks which may have been used as infilling for the walls. The buildings were destroyed by fire so early within the structural sequence as first to suggest its equation with the documented razing of the city by Boudica in

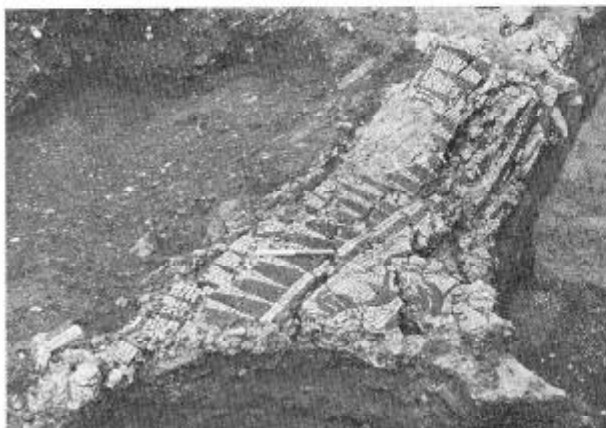
Fig. 3: First century mosaic floor in Room 1 of Structure 4, viewed from the south-west. The scale is in 0.10m (4in) units.  
(Photo: Jon Bailey)

In the southernmost building (Structure 4) the load-bearing walls had been built on a dwarf wall of ragstone in mortar bonding. Several of the rooms had been appointed with red and white plastered walls, and a number of high quality floors had been laid. A mosaic floor (Fig. 3) in the east end of the building (Room 1 on Fig. 2) was made from small squared black and white tesserae set into a mortar base. The design consisted of a strip of alternating black and white triangles above a floral border of leaves, scrolls, and tendrils. Black and white geometrical designs of this type were most popular during the early Roman period in Britain; more brightly coloured mosaics were rare until the later Roman period. Other floors in the building were of *opus signinum*, a mixture of tile fragments in sandy mortar which had been ground down and polished to a smooth surface. A quarter-round moulded skirting of *opus signinum* was also laid in two of the rooms. In three rooms (Rooms 2, 3 and 4 on Fig. 2) mosaic designs had been set into the *opus signinum*: this was technically complex operation as the tesserae would have been laid before the *opus signinum* had set, and floors of this type are rare (Fig. 4).

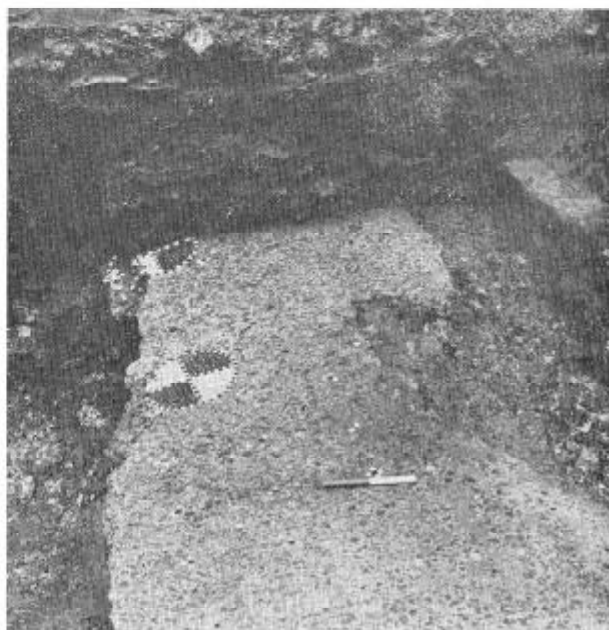
Fig. 4: Mosaic roundels set into the *opus signinum* floor of Room 4 of Structure 4, viewed from the north. The scale is in 0.10m (4in) units.

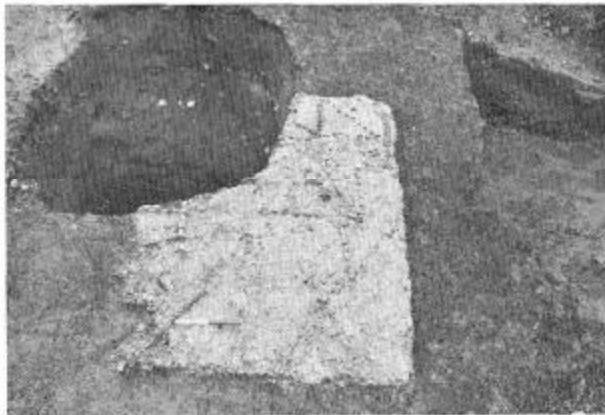
Fig. 5: Tessellated design in Room 5 of Structure 6 as revealed after the removal of the mortar floor, viewed from the north. The scale is in 0.10m (4in) units.

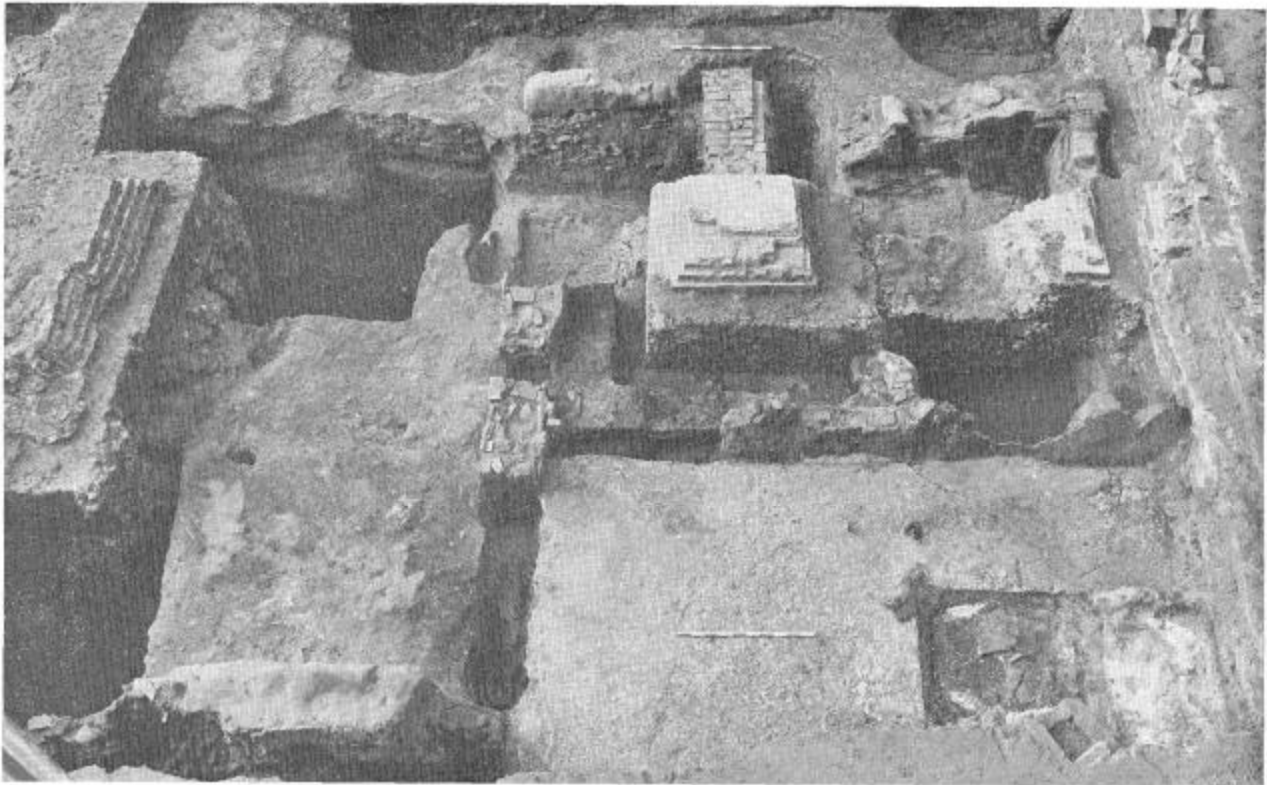
Fig. 6: Structure 8 viewed from the east; the concrete and brick foundations are modern. The scale is in 0.10m (4in) units. (Photo: Trevor Hurst)

The northern building (Structure 8) was generally similar to the southern, although its load-bearing walls were differently constructed. In these the walls were built of brickearth bonded tile beneath puddled brickearth (Fig 6). These walls survived, in places, to a height in excess of 1m (3ft 3in) and no trace of a superimposed timber structure survived the post-destruction clearance. It is possible that these walls were built entirely of tile and brickearth to first floor level. The destruction debris within this building survived well (Fig. 7). A thin band of charcoal had been formed when the timber elements (doors, furniture, etc) were burnt away, and some of the plaster from the walls had also fallen away before the ceiling and roof collapsed. The ceiling plaster lay in a jumble on the floor. Some sheets of plaster had fallen directly to lie face down, but most of it had fallen in an arc to end face up. This plaster could be distinguished from the wall plaster by the impressions of the ceilings lathes into which the plaster had been pressed (lathes had not been used in the construction

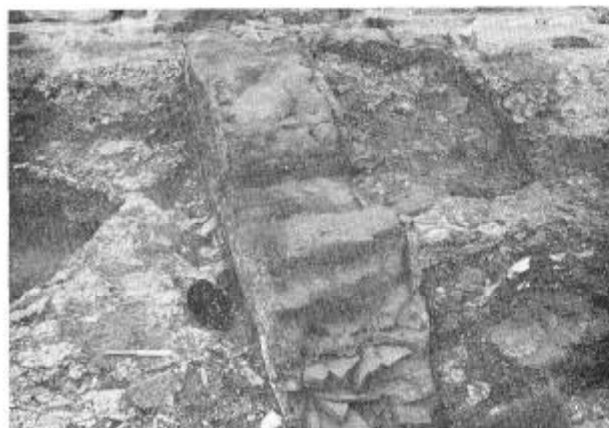
Fig. 7: Detail of a wall within Structure 8 also illustrating the partially excavated destruction debris of plaster and brick. The scale is in 0.10m (4in) units.  
(Photo: Jon Bailey)
