Ironmonger Lane

JENNIFER NORTON

EXCAVATIONS IN THE AUTUMN of 1980 on the site of Nos. 24 and 25 Ironmonger Lane (TQ 3250 8123) took place over a four month period, in advance of redevelopment of this and the adjacent area to the west fronting onto King Street (Fig. 1). The excavations were carried out by the Department of Urban Archaeology (Museum of London), and generously funded by the developers, Guardian Royal Exchange Assurance.

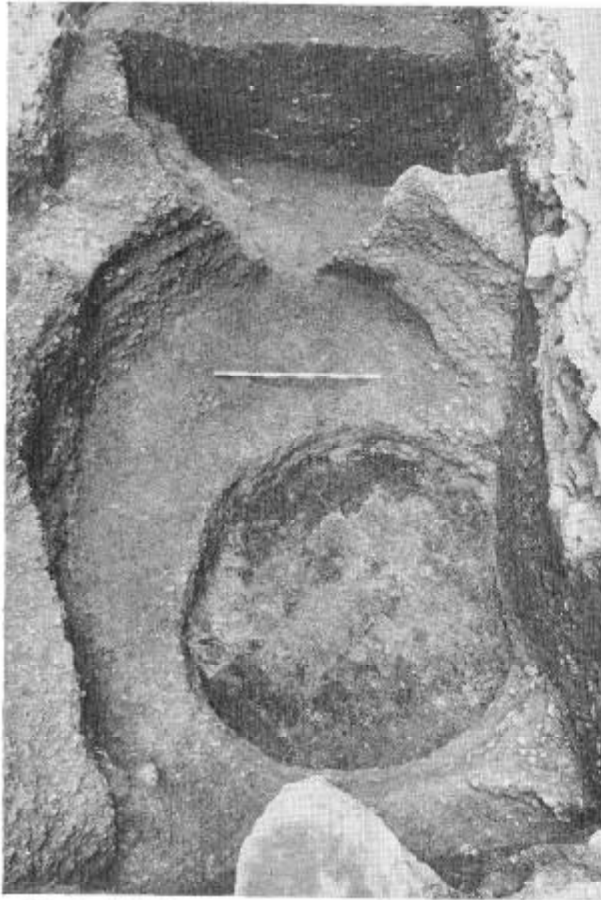
Fig. 3: Oval Saxon sunken feature with circular ash pit, with a section across the larger sunken feature in the background. (Photo: J. Bailey)

through the disused Roman street gravels to a depth of 1.00m (3ft 3in). Both had vertical sides, and utilised the same compacted Roman road surface to provide a firm base (Fig. 3). Only part of the larger eastern feature lay within the area of excavation, but it was probably about 5m x 4m (16½ft x 13ft) with a post setting at the base of the central point of the northern side, presumably supporting a ridge pole secured onto a second timber. Two phases of occupation, represented by gravel and tile fragments forming areas of compaction with the trodden surfaces, produced a general build-up of occupational material angled up against the gravelled walls, before tips of rubbish marked the disuse and back filling of the feature.

The smaller feature, which was oval in plan (3.6m x 2.40m; 12ft x 8ft), was an addition following the primary occupation in the larger feature, and contained a large circular pit with *in situ* ashy deposits. The main body of the feature showed a similar build-up of uneven surfaces and occupational debris, associated with bedding gravels for a horizontal timber and, later, a number of post settings along the base of the northern wall.
