# The Roman Riverside Wall in the City

CHARLES HILL

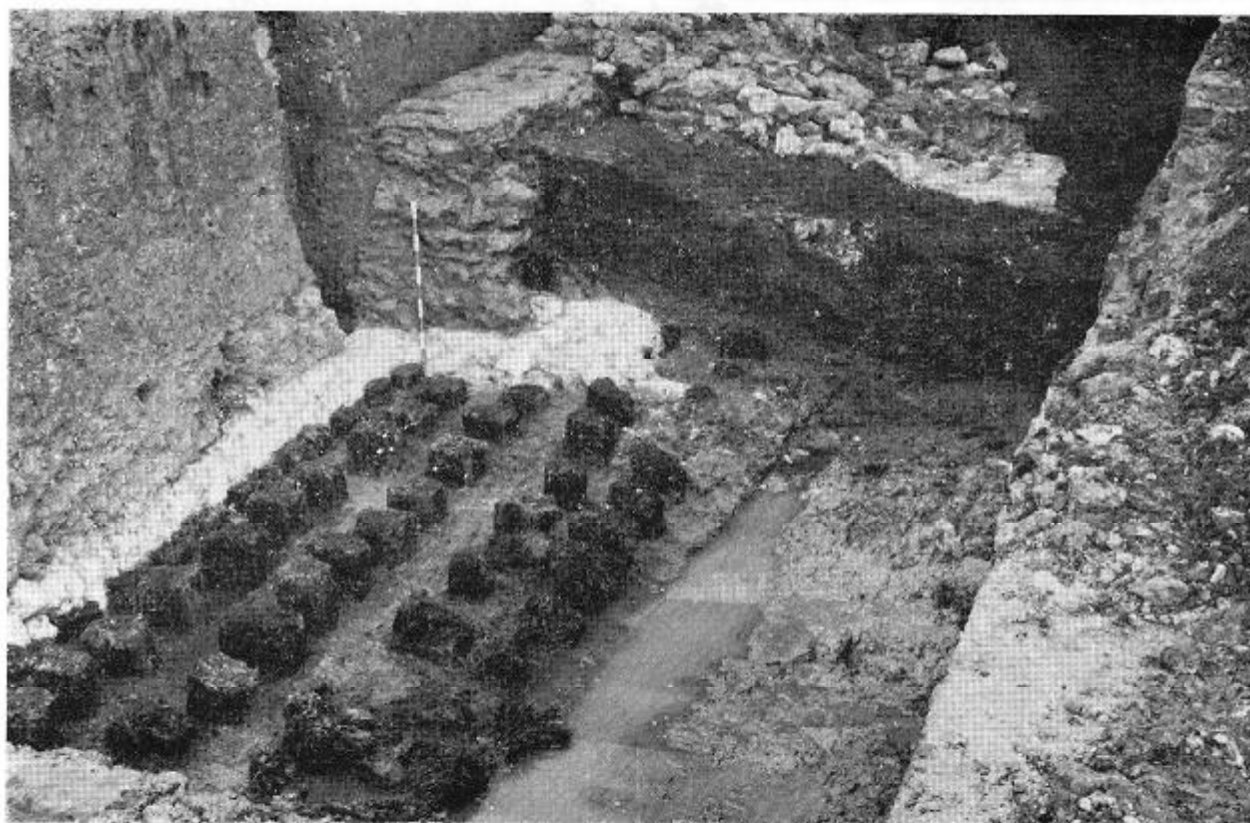
Fig. 1. The foundations of the wall showing the oak piles cleared of their chalk packing; two of the tile courses are also visible. (Photo: Trevor Hughes, Guildhall Museum, D.U.A.)

The first stage in the construction of the wall involved the ramming of square oak piles, worked with an adze, into the natural gravels and clay (Fig. 1). The timbers, of which over one hundred were found, were arranged in five neat rows, with the longest timber placed in the outside rows. Around and above these piles a thick layer of chalk was added, 3.3m. wide. On to these footings the main body of the wall followed, comprising firstly a stratum of ragstone set in hard greenish mortar. The rest of the wall consisted of ragstone, with some flint and chalk, set in yellow mortar with flecks of crushed tile. Three double bonding courses were found composed solely of new roof tiles (*tegulae*), unlike similar courses on the land wall which are made of the usual flat "bonding tiles." The *tegulae* were laid with their flanges facing downwards, presumably to provide a better form of bonding across the width of the riverside portion of the wall which because of the nature of its foundations, was more liable to suffer stress from subsidence.
