THE DEPARTMENT OF URBAN ARCHAEOLOGY MUSEUM OF LONDON  
CHIEF URBAN ARCHAEOLOGIST: BRIAN HOBLEY

## THE EXCAVATION OF A ROMAN PALACE SITE IN LONDON, 1961-1972

BY PETER MARSDEN

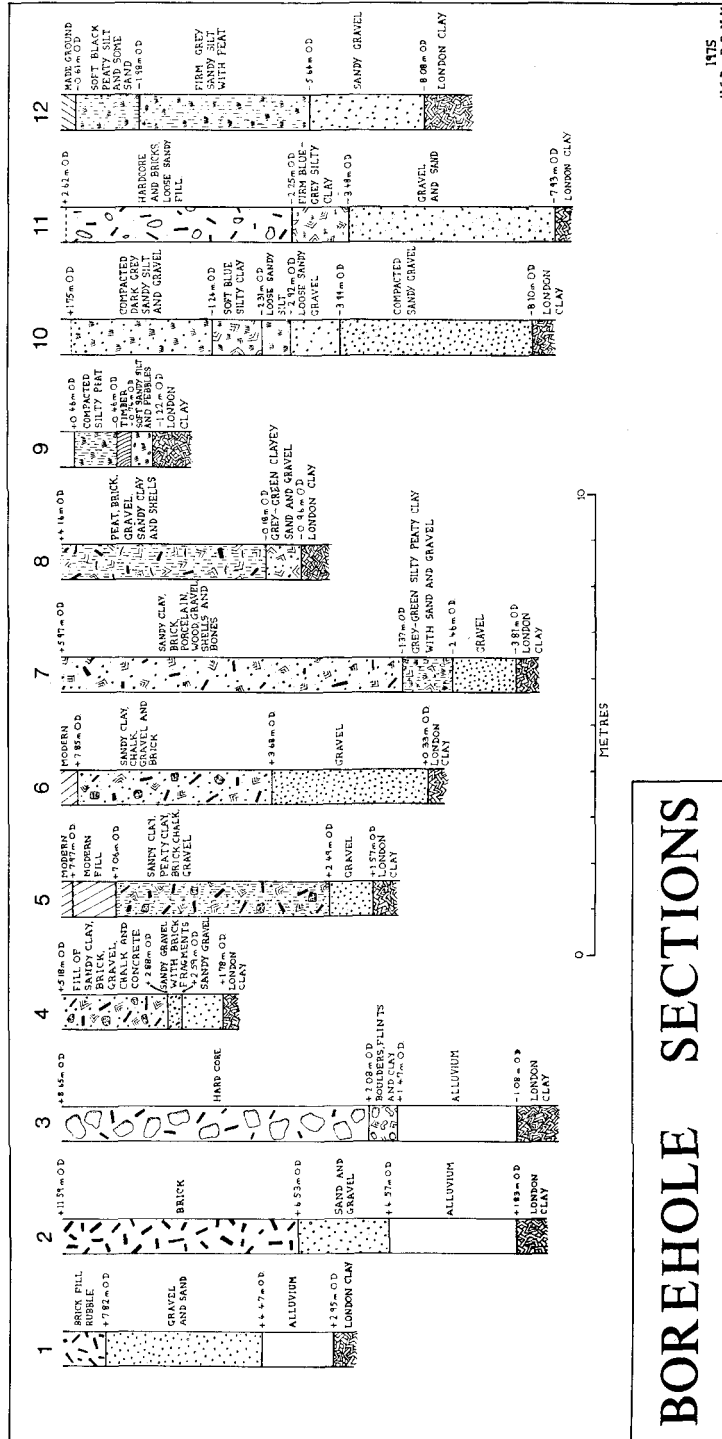
Fig. 3 Roman Palace. Borehole sections recorded during commercial site investigations

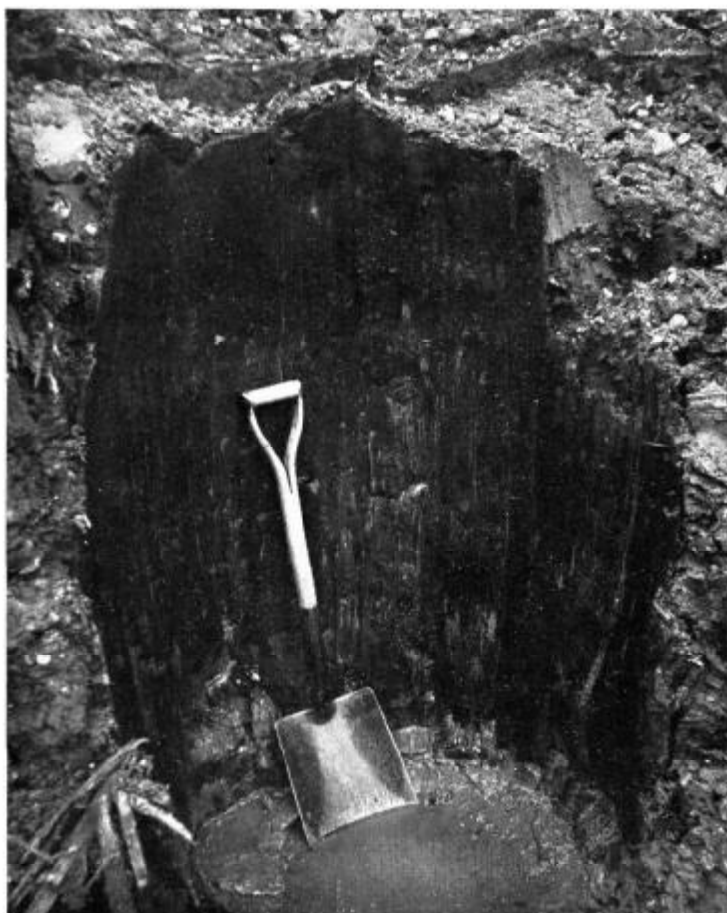
Plate 1 Roman Palace. Flavian barrel forming the bottom of Well 2.

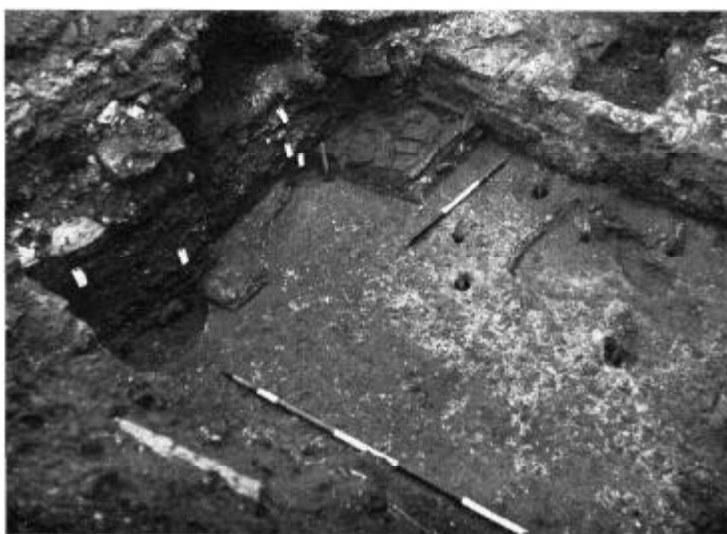
Plate 2 Roman Palace. Room 14 and late Roman hearth. Scale of feet; view to north.

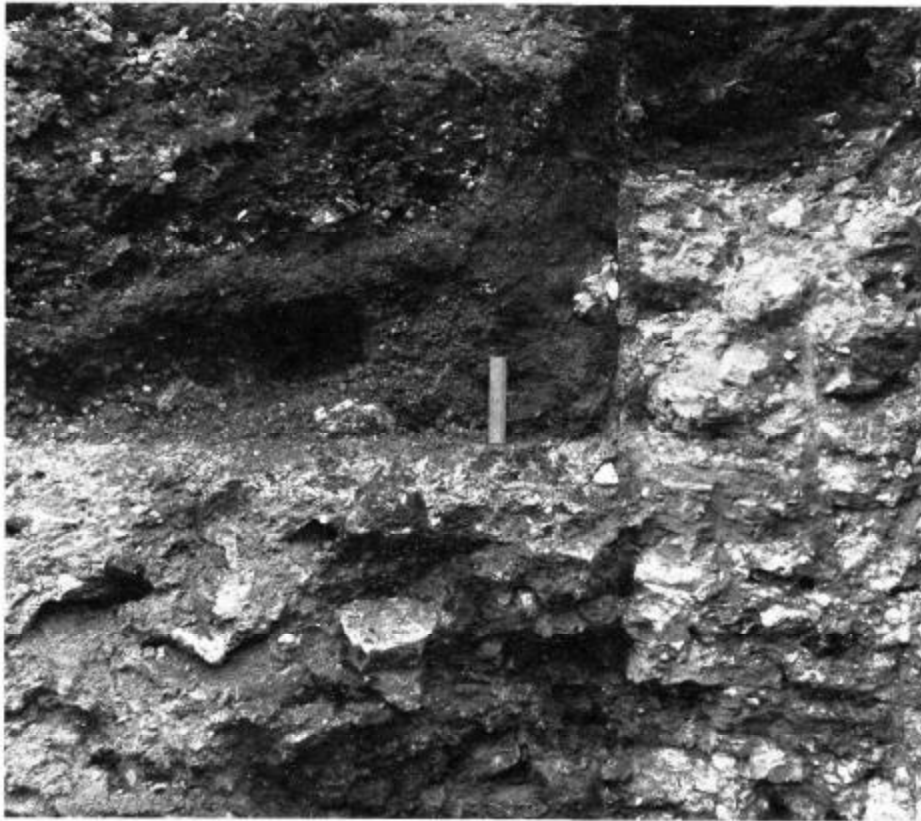
Plate 3 Roman Palace. Junction of north wall and bottom of great pool (Feature 46).  
Scale of 6 inches

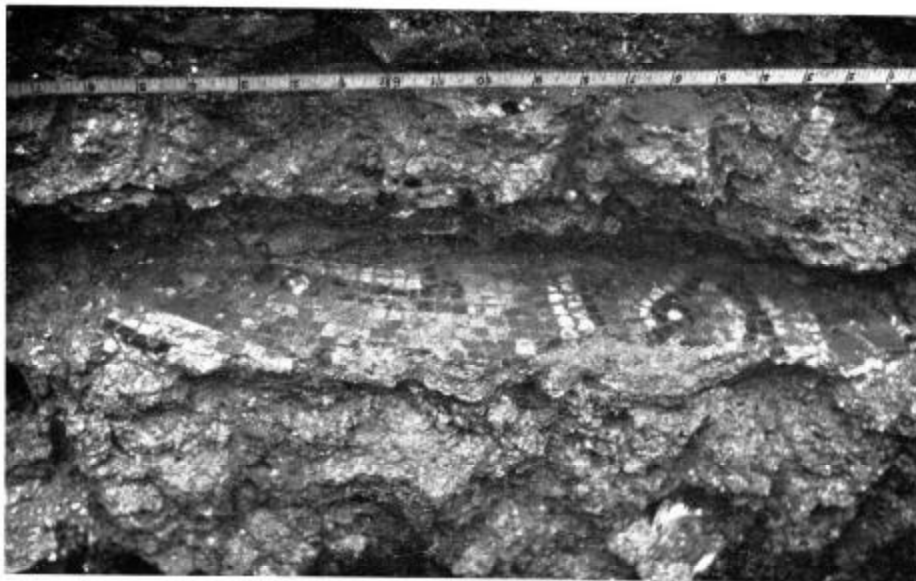
Plate 4 Roman Palace. Patterned mosaic with guilloche border, seen in Room 67  
(see Fig. 44). Scale of inches
