EXCAVATIONS ON THE SITE OF ST NICHOLAS SHAMBLES, NEWGATE STREET, CITY OF LONDON, 1975-9

John Schofield

SUMMARY

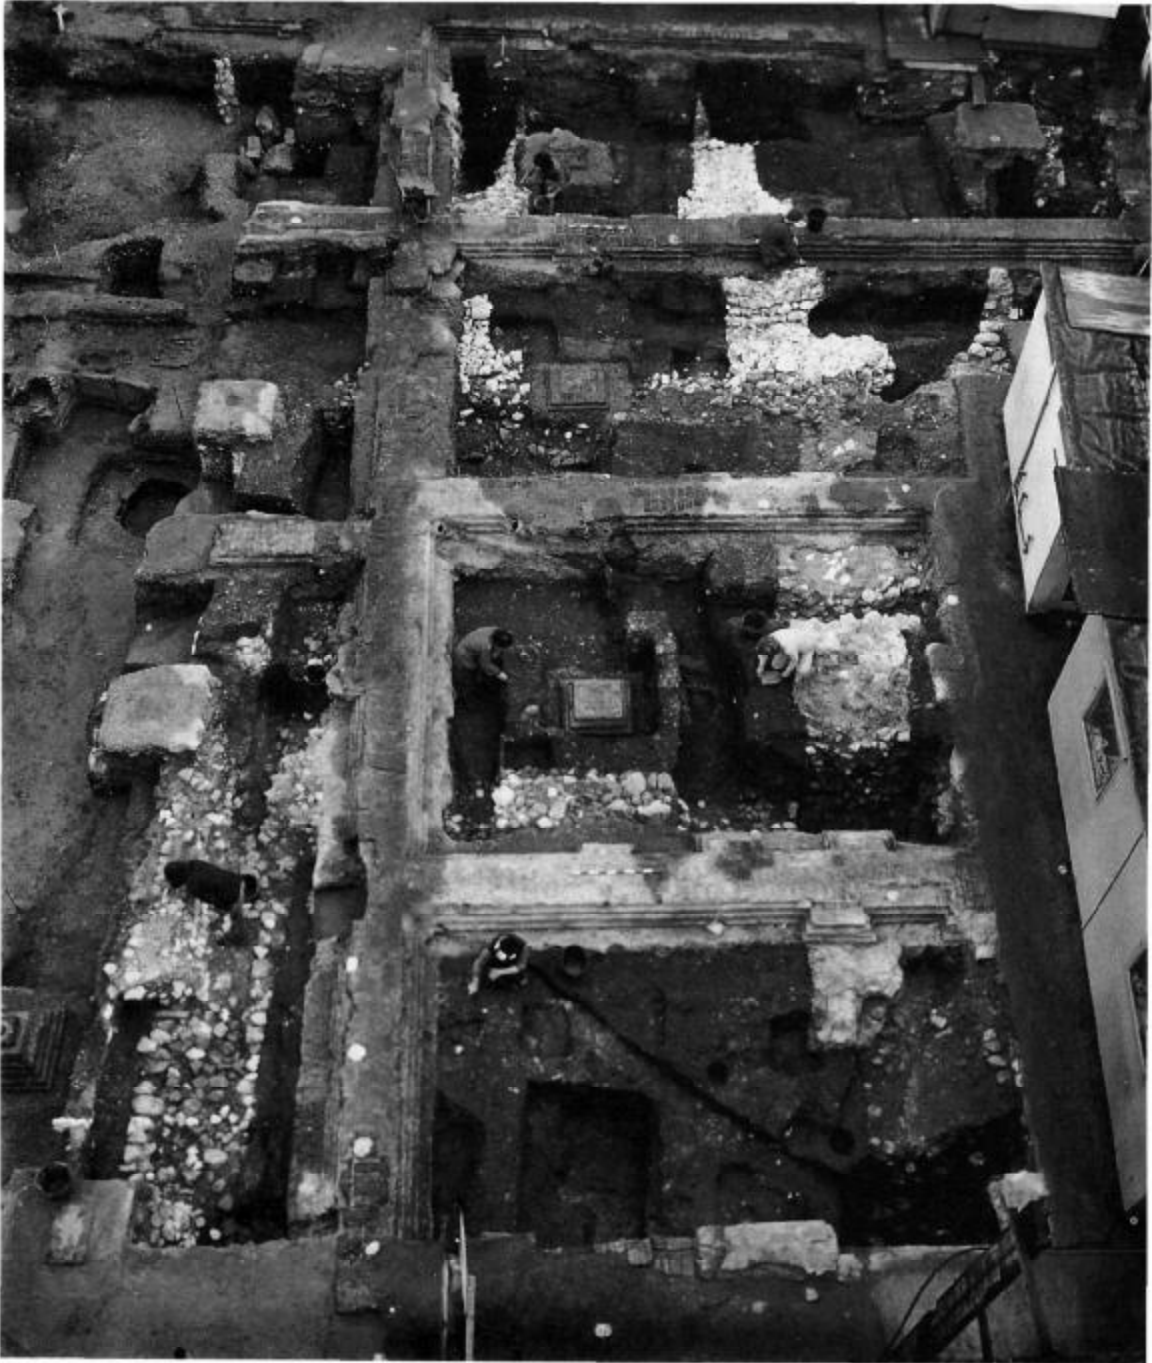
Fig 7. The excavations looking east, showing foundations of phases 1 and 2 of the church. The extension of phase 2 (sanctuary) is seen here as the chalk foundations at the east end of the church (compare the plan in Figure 14). In this and similar photographs the brick foundations crossing the site are those of the 19th-century General Post Office building

The earliest phase of the church comprised foundations of a nave and chancel (shown under excavation in Figs 7 and 8). The west end of the nave, in this and all subsequent phases, was not recorded, as it lay beyond the western limit of excavation and under the pavement of King Edward Street (widened in the 19th and 20th centuries); the frontage of the street in the early 19th century, postulated from documentary and

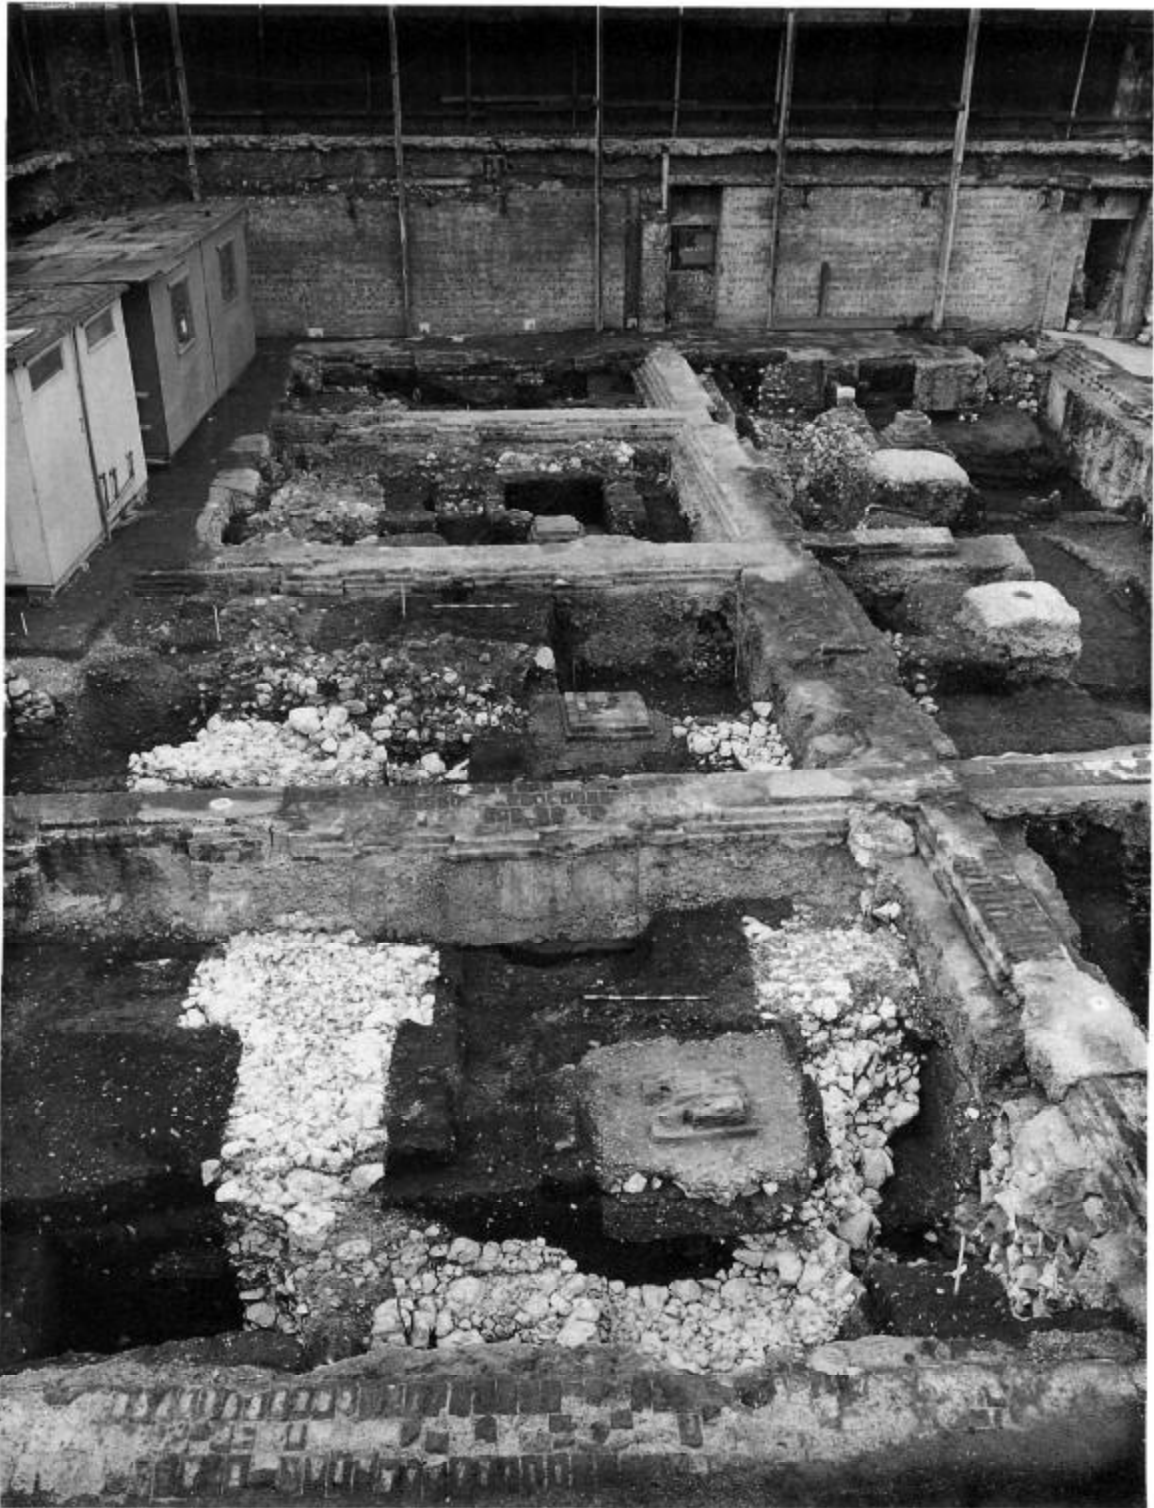
Fig 8. The foundations looking west, showing foundations of phases 1 and 2 (the latter as chalk foundations in the foreground; compare the plan in Figure 14). The line of King Edward Street in 1975 (since widened) is at the back. Scales are 10 × 100mm units

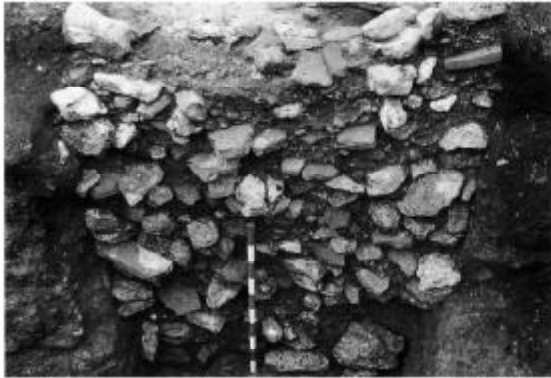
Fig 10. Section through the foundation of phase 1 church on the south side, looking east (for position see Fig 6). Scale is 10 × 100mm units

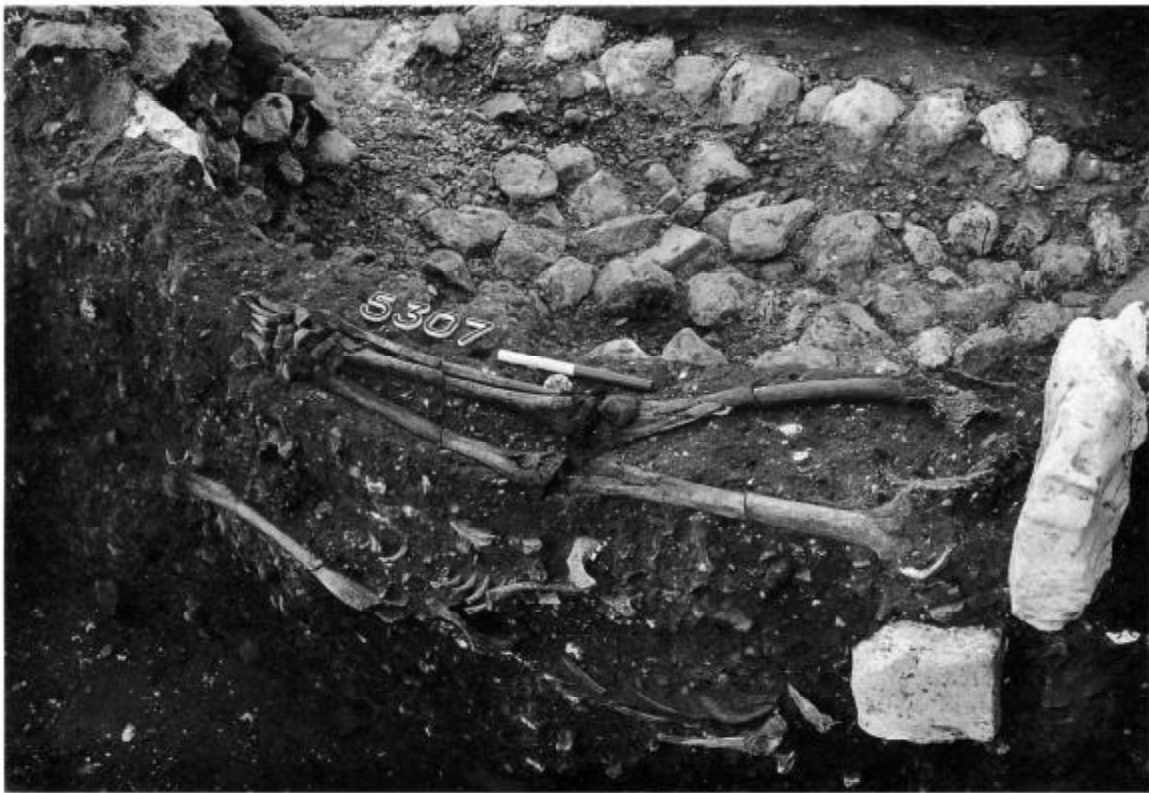
Fig 13. Phase 1 or 2, burial 5307, looking south-east. Scale is 2 x 100mm units

possibly within an earlier cist which contained another skeleton (Fig 13). These two burials overlay four others, indicating a succession of interments before one of the uppermost two burials encroached on the foundation of the church. These two cists each contained pieces of reused roofing tile, although of slightly different dates within the 12th century (see Building Materials report, below). Burial G17.1 contained a curved tile probably of mid-late 12th-century date, and burial G17.8 contained pegtile of late 12th-century date. The implications of this possible grouping of graves over which more than usual care has been taken is considered in the Discussion section below.

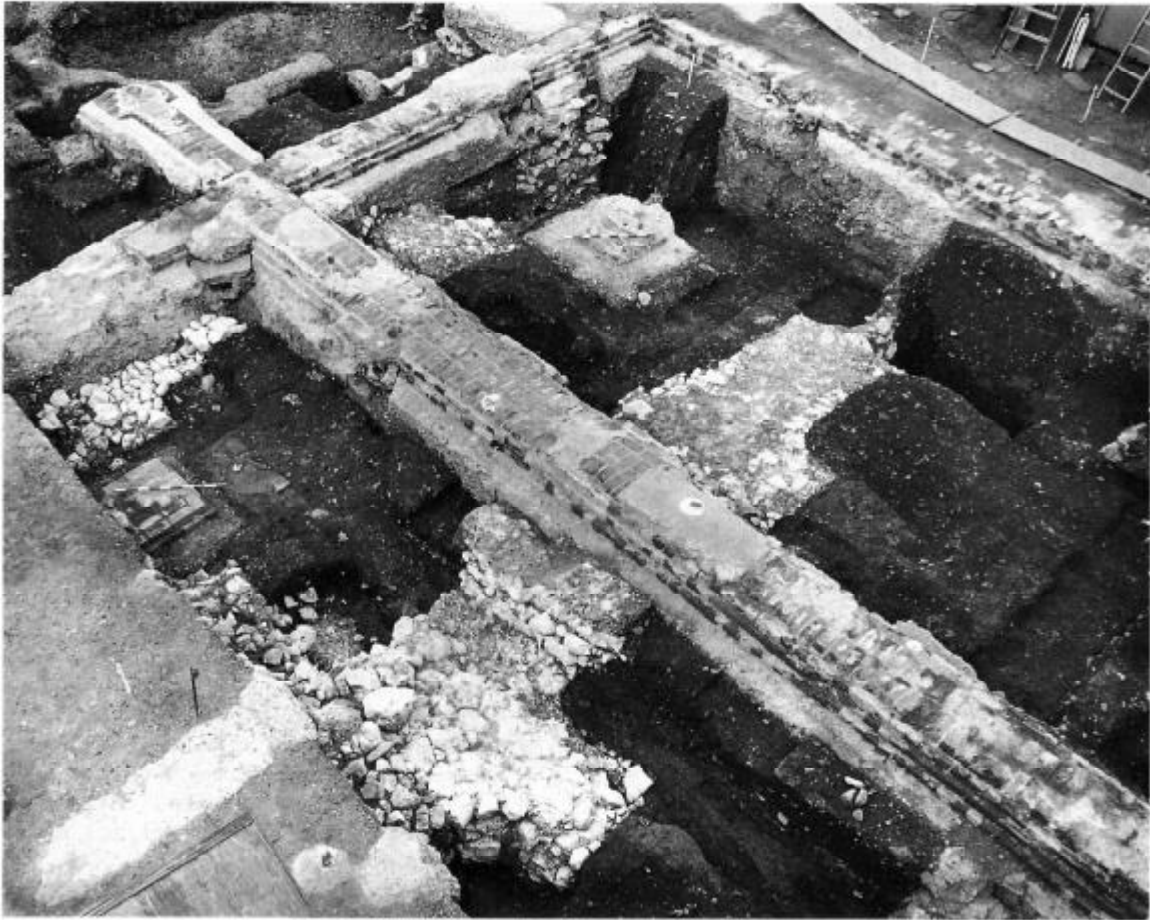
Fig 15. Phase 2 extension, looking north-east. Scale is 10 × 100mm units

The first group comprised two east-west foundations (G19.1 and G19.2) which formed abutments to the existing east end and the starting-points of the north and south walls of the new structure (Figs 14–15). Both were constructed of courses of rammed chalk, so closely packed that the interface between

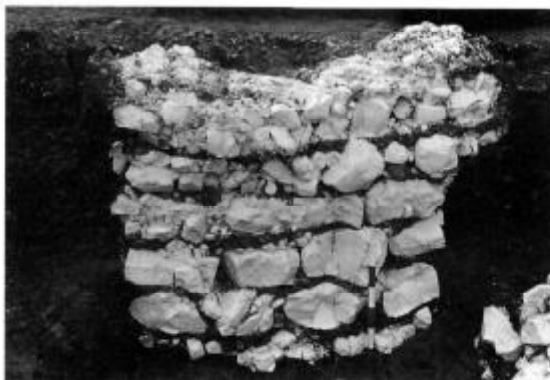
Fig 16. Section through the foundation of phase 2 church on the south side, looking east (for position see Fig 6). Scale is 5 × 100mm units

individual blocks was often not visible (Fig 16). These layers were separated by thinner layers, three of which were recorded on the north side (G19.1): crushed chalk with crushed grey/green laminated sandstone, orange sand and pebbles, and dark brown soil with pebbles. A similar layer in the south foundation (G19.2) was of pebbly grey soil. In addition, some 5% of the foundation consisted of ragstone. The trench for the northern foundation included, at its base, layers of reused Roman building material.

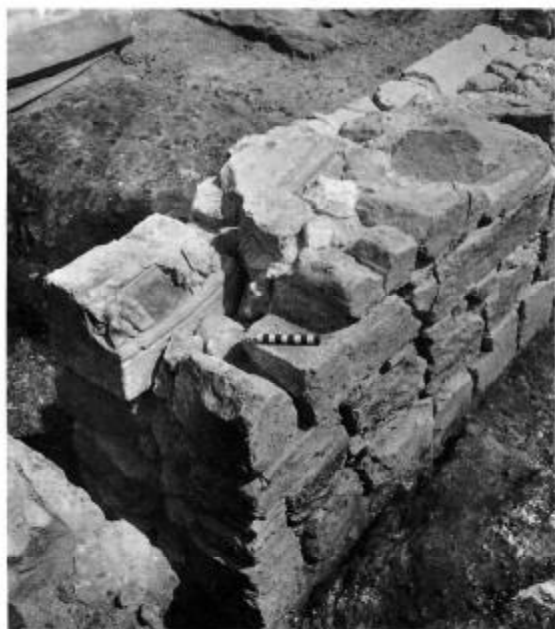
Fig 17. Moulded stones reused in a wall of Bull Head Court. The stone with the flowers is one of the group from a window arch of 1270–1330 (<3405>, Fig 30 No. 16). Scale is 10 × 10mm units

Several further building works earlier than 1350 are suggested by other stones. One group came from a lancet window of 1200–70. Another comprises fragments from a pier and matching capital of late 13th or early 14th-century date which may derive from an arch or an arcade; some bore traces of red and black or blue paint. A third relevant group of stones suggests a window of 1270–1330 (Fig 17). Fourthly, a stone

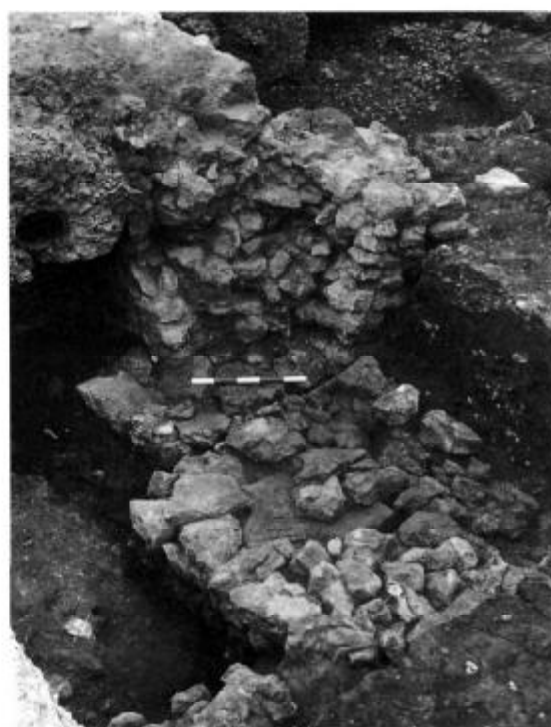
Fig 23. Phase 5, foundation G26 looking north-west, showing it comprising parts of a 13th-century stone coffin cover, <1262>. Scale is 5 × 100mm units

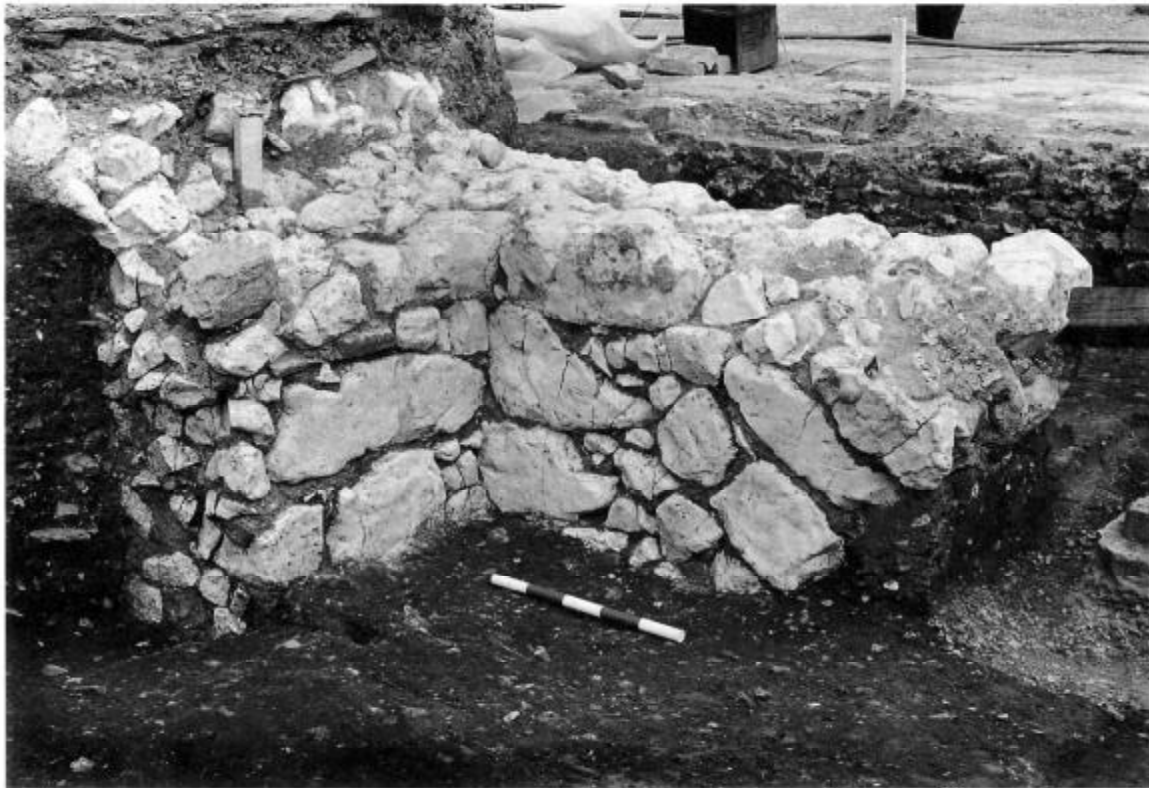
Fig 24. Phase 5, foundation G25 of vestry, looking north-east. Scale is 5 × 100mm units

North of this group, foundations formed three sides of the vestry (G25.1–2, G30.1). These were of chalk, Kentish Rag and medieval roof tile in sandy orange mortar, and arched (Fig 24). At the same time a foundation of similar character, but not arched, was laid against the north-east corner of the north aisle (G25.4). This may have been as the base for a rood stair, entered from the aisle; it aligned with the chancel arch to the

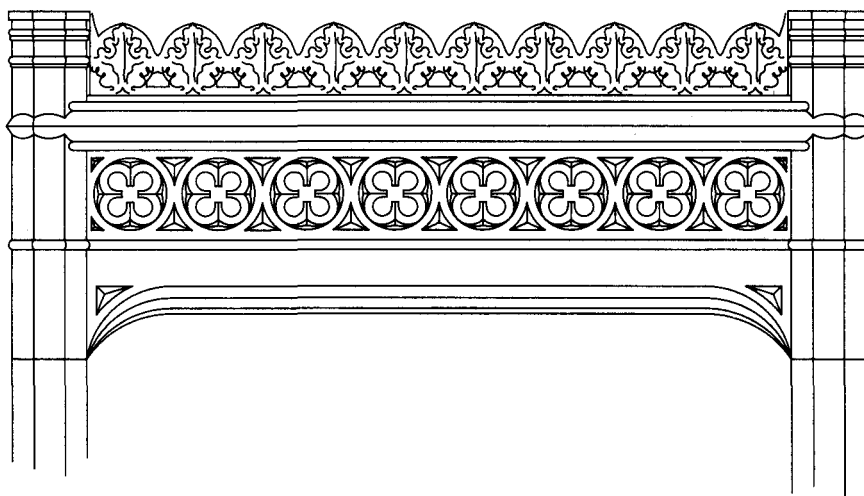
Fig 25. Reconstruction of the canopy of a monumental tomb of 1475–1500, from stone <3655> (Fig 35, No. 84)

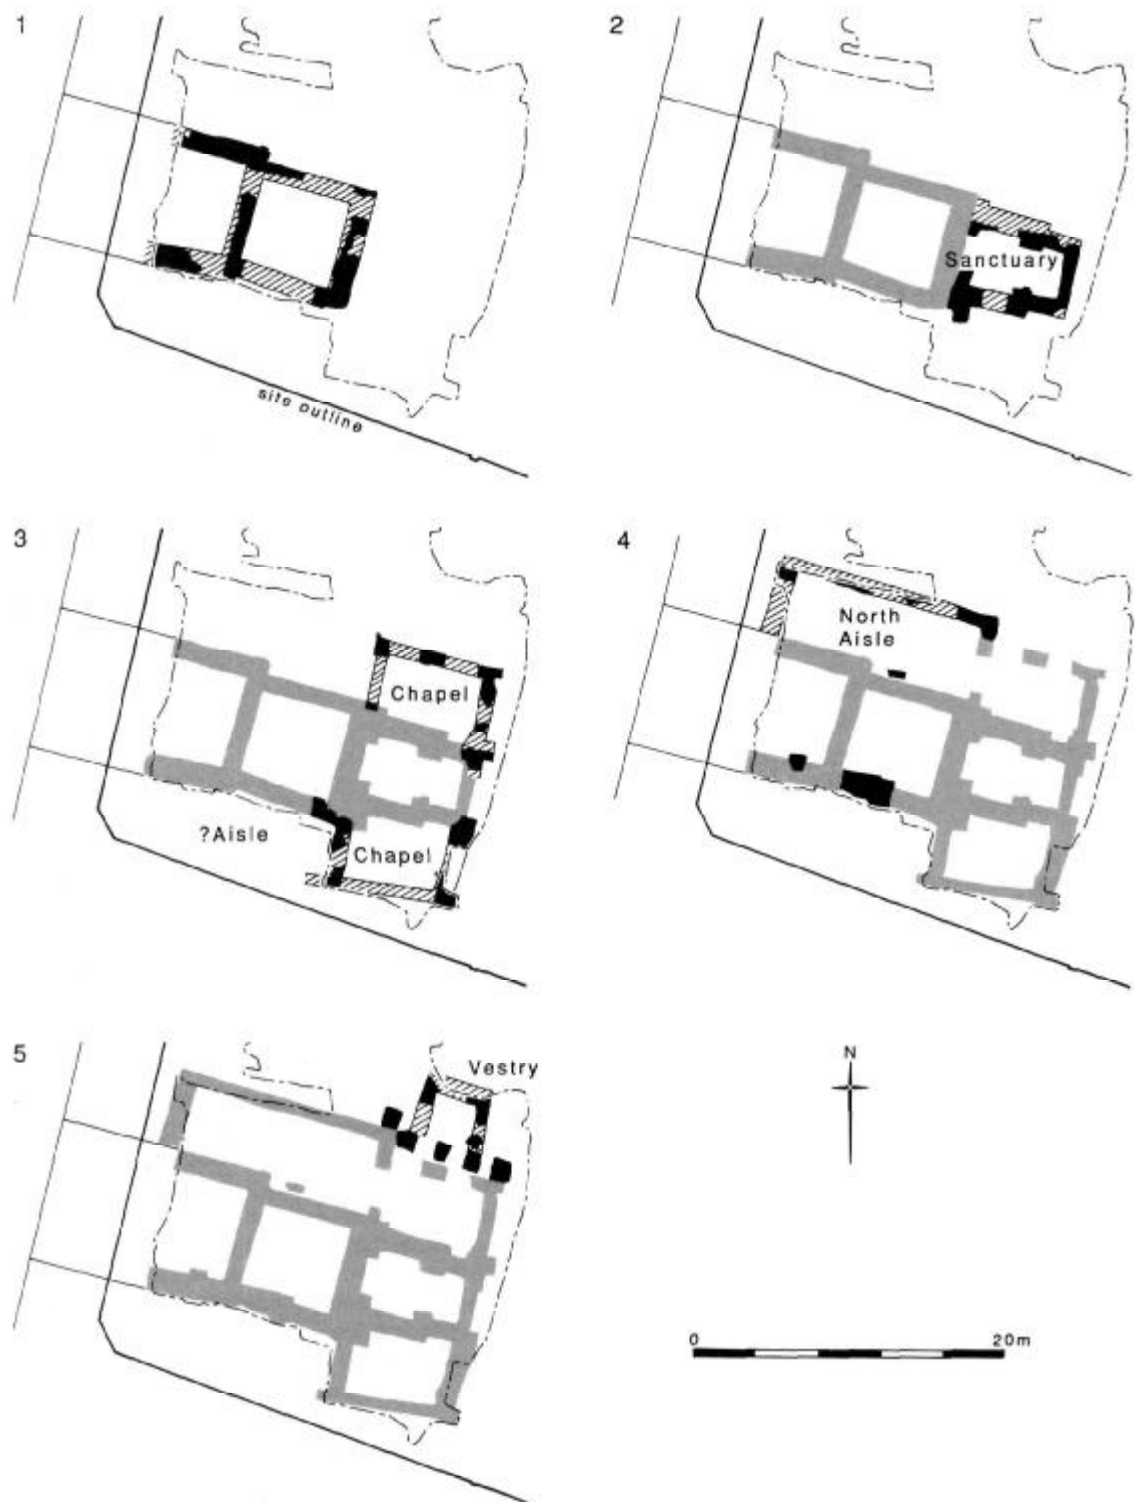
Fig 26. Development plan of St Nicholas Shambles, phases 1 to 5: 1, 1000-1150, probably before about 1144; 2, 1150-1250, possibly to 1330; 3, 1340-1400; 4, ?1400-50, possibly in stages; 5, 1400-50, monuments 1470s+ (to 1547)

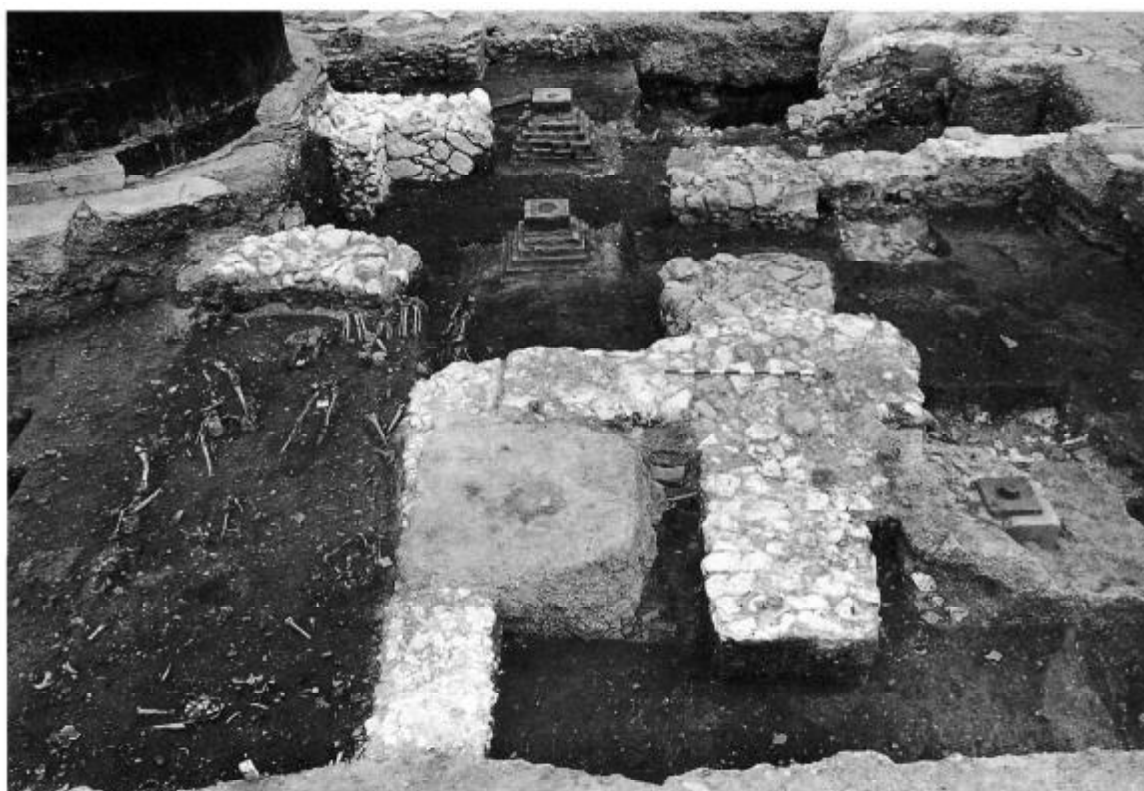
Fig 28. View of eastern part of excavated area, looking east, and showing part of the northern graveyard (left) and the east end of the church (centre and right). Scale is 10 × 100mm units

The main cemetery of St Nicholas was on the north side of the church (Fig 28); it is first mentioned in documents as being on this side in the early 14th century. The excavation recorded 234 skeletons; methods of preparing the grave in 45 cases were of early medieval (pre-1300) character (White 1988), and the burials are
